Spinal Neurosurgery Report **Fracture of anterior cervical plate implant – report of two cases**

C. P. Yen, T. Y. Hwang, C. J. Wang, and S. L. Howng

Department of Neurosurgery, Kaohsiung Medical University Hospital, Kaohsiung, Taiwan

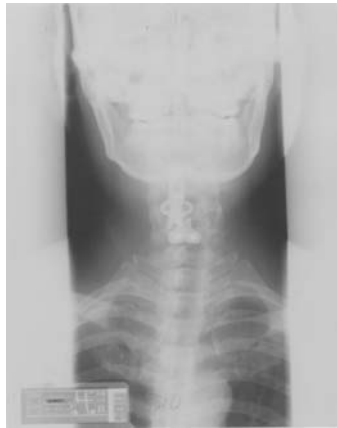
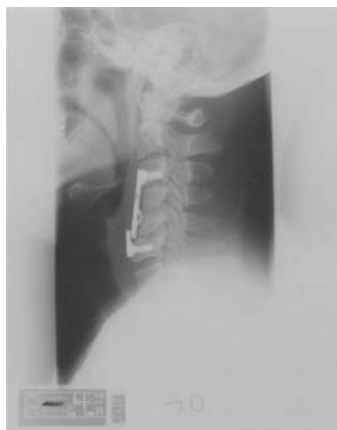
Fig. 1. (a, b) Radiographs 18 months after surgery showed fracture of the cervical plate. A radiolucent gap between the graft and the inferior surface of C3 vertebral body was also noted

A 46-year-old female with a known history of cervical spondylosis was involved in a motor vehicle accident, which aggravated a pre-existing myeloradiculopathy. When the magnetic resonance imaging (MRI) revealed C3–C6 disc disease with multiple spur formation, a C3–C6 discectomy, C4–C5 corpectomy and fusion with iliac crest autograft was performed followed by instrumentation with Cervical Spine Locking Plate (radius 25 mm) (Synthes Spine, Paoli, PA). The operative procedure went uneventfully and the neurological deficits disappeared completely after surgery except for mild neck pain. Three months later, a pseudoarthrosis was demonstrated at the C3 vertebral body-graft interface. Because of trivial symptoms, instead of offering the patient posterior wiring and fusion, she was left in a cervical collar and followed with imaging studies. Eighteen months postoperatively, she twisted her neck on a roller coaster and experienced neck pain without neurological deficits. X-ray revealed a fracture of the plate through the midline hole at the lower aspect of the plate (Fig. 1). The superior pseudoarthrosis remained unchanged. A second procedure was performed and during surgery residual disc tissue was identified between C3 vertebral body and graft. An anterior fusion was repeated with a Caspar plate (Aesculap, San Francisco, CA). Follow-up x-rays ultimately showed complete fusion and she later requested elective plate removal.

In both of our cases, no metallurgical flaw was identified. Pseudoarthrosis is considered as the main etiology

responsible for the plate fracture. In the anterior plated reconstruct, the axis of rotation is shifted anteriorly [6]. As the capability of the plate to stabilize the spinal reconstruct following long segment corpectomy is significantly reduced after fatigue loading [4], lack of solid union forces the plates to keep on sustaining most of the stress. A long-term fatigue loading and a sudden stress caused by a twist of the neck finally led to plate fracture. Fortunately, both of them did not suffer a neurological catastrophe although minimal neurological complications have been reported to be associated with the implant failure [5]. Another possible reason causing the fracture might be the contouring of the plate. Uneven anterior vertebral surface is quite common in patients with advanced degenerated spinal disease and cervical lordosis should also be taken into consideration while applying the implant [1]. Therefore, the straighter design of the Cervical Spine Locking Plate necessitates more or less contouring for optimum fit. Using the bending device, the area containing the midline screw hole is most susceptible to bending force and a crack may be caused at this vulnerable area becoming a weak point. The crack progresses as a combination of fatigue and stress [1]. Once a sudden stress occurs, the additional force transfers through the locking screws to the plate and contributes to eventual fracture through the weak point. We do not routinely use additional screws to the graft through the midline holes, because this could risk the graft to fracture and transfer more stress to the neighboring plate.

As with lumbar spine instrumentation, mechanical failure of plated ACF should always raise the suspicion of nonunion [5, 7]. To achieve a good fusion, adequate preparation of the recipient trough after corpectomy is a prerequisite. Inappropriate bending of the plate especially bending back and forth is forbidden. Newer commercialized anterior cervical plates have already been molded to simulate the lordosis of cervical spine. If the curve of the plate still does not fit and adjustment is inevitable, careful contouring avoiding the site con-

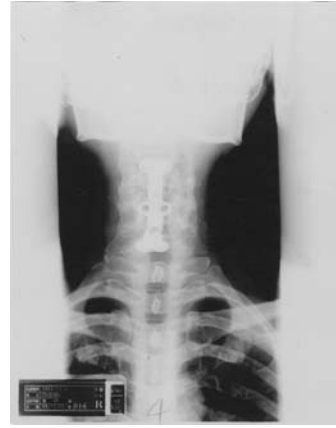
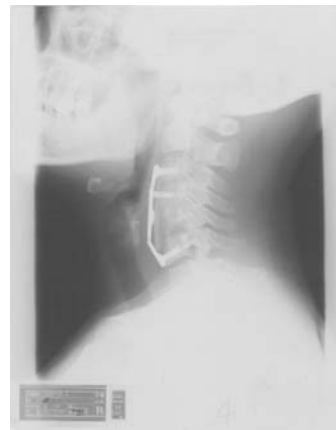
Fig. 2. (a, b) Radiographs four months after surgery showed fracture of the cervical plate and protrusion of the bone graft

A 45-year-old female who suffered from cervical myelopathy due to OPLL combined with herniated discs underwent a C4–C5 corpectomy, removal of OPLL, C3–C6 autogenous iliac graft fusion and anterior instrumentation with a Cervical Spine Locking Plate. The patient was placed in a neck collar for 8 weeks after surgery. The neurological symptoms and signs resolved completely and follow-up x-rays revealed progressive union. Four months after surgery, during an argument with her husband, she was slapped in the face and twisted her neck when she experienced neck pain and dysphagia. Neurological examinations did not reveal any new deficits but x-rays showed a plate fracture with graft protrusion (Fig. 2). Surgery for a revision was carried out using the original graft and a new cervical plate. No reason could be identified for the delayed fusion. The patient made an uneventful recovery and follow-up radiographs one year later also showed good fusion.
